# **Energy Audit Report**

## **68 Magoun Avenue, Medford, MA**

**Date:** December 23, 2008

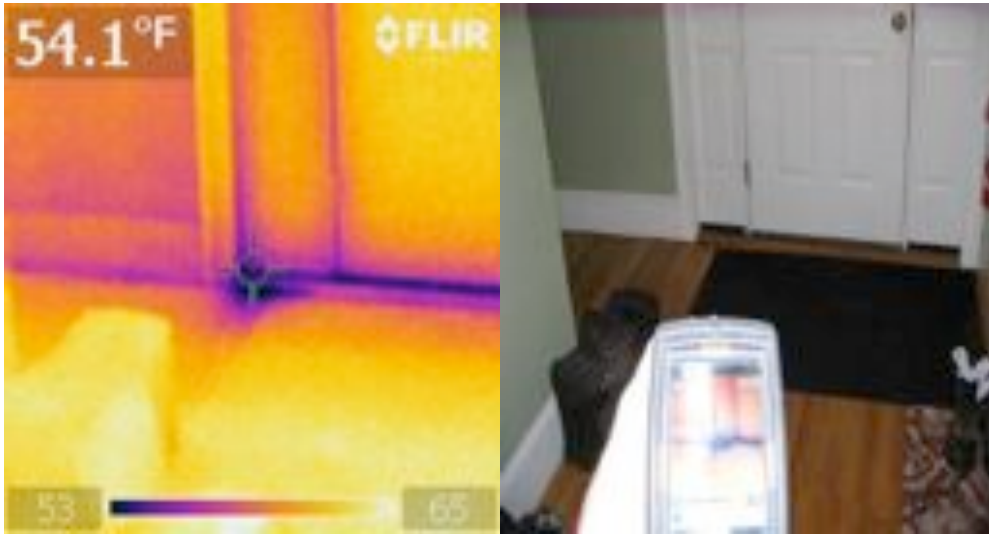
This image is of the front door, and illustrates a small amount of cool air leaking in the left corner of the front door, without the blower door operating, due to the force of stack effect. This airflow was perceptible with the back of the hand.

The air leakage above is not very significant in the context of overall building energy use, but could be improved to provide greater occupant comfort.

Understanding the value (both economic and user comfort) of making improvements to the building is key to cost effectively addressing energy use reduction and improving occupant comfort. This is a low value improvement, which might be made because the cost is so low, basically just a bit of caulk.

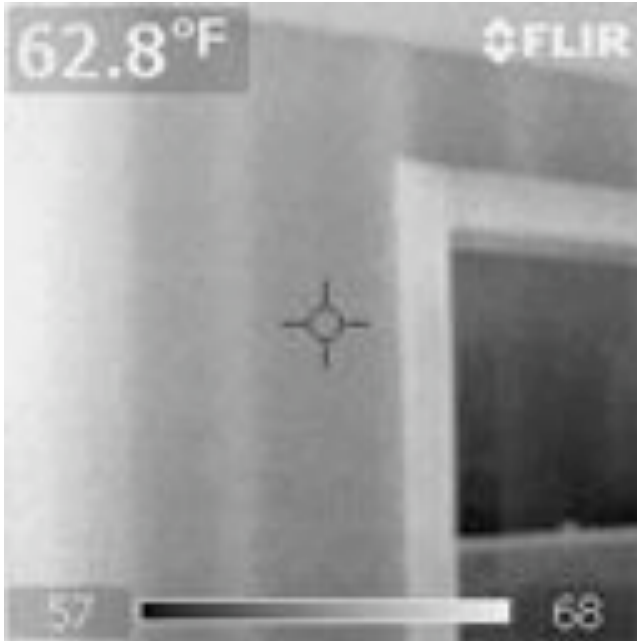
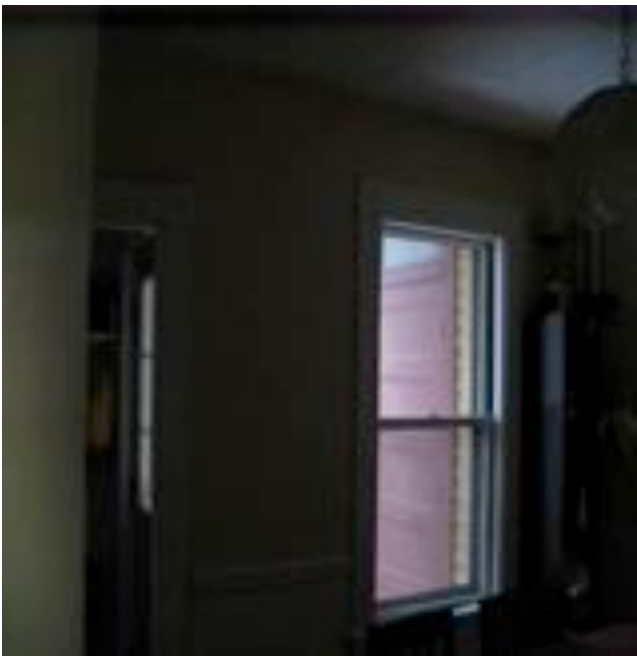
These images illustrate the many areas of un-insulated, or poorly insulated stud cavities.

The studs are a lighter color (warmer) than the stud cavities.

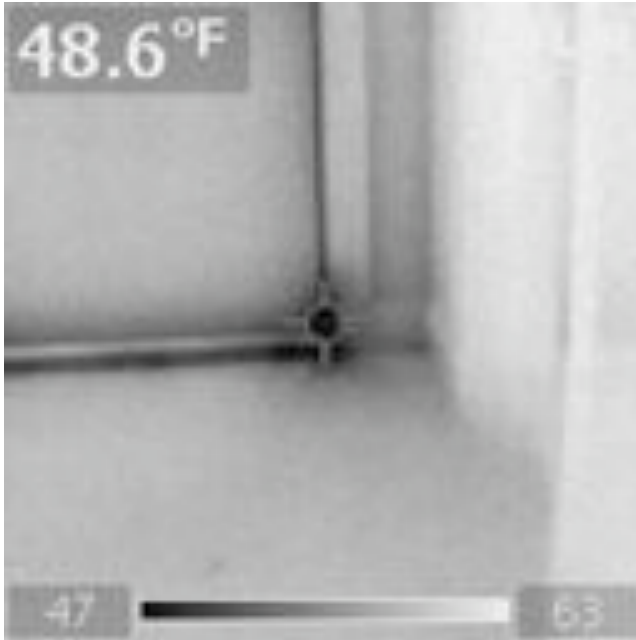
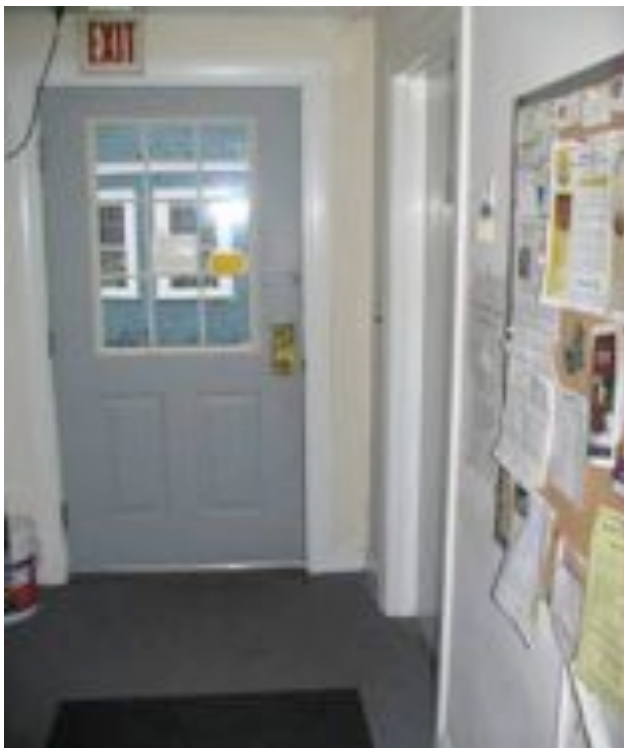
The lower right corner of the door gasket is leaking air, due to stack effect induced pressure .

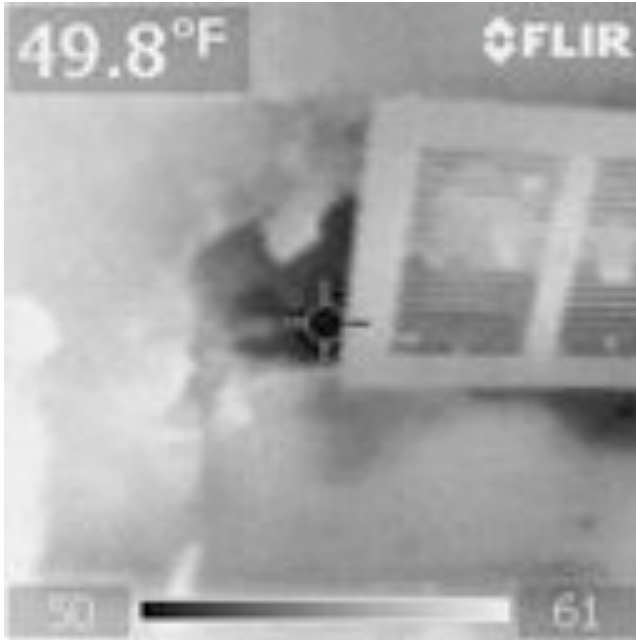
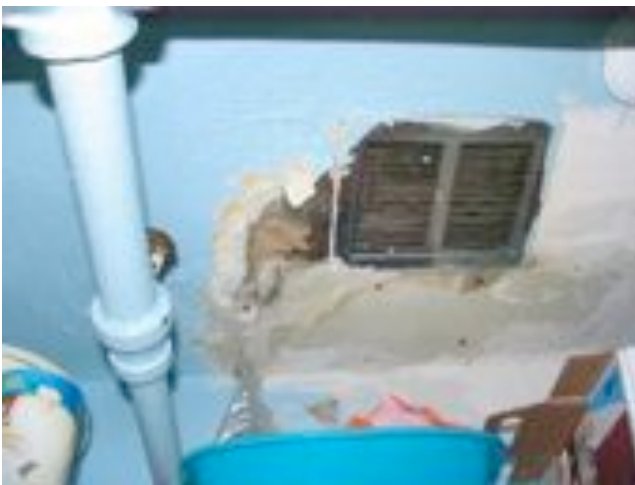
Low temperature air and / or moisture is finding its way into the building, possibly due to the path of the duct connected to this vent. There may also be a correlation to the apparently water induced damage.

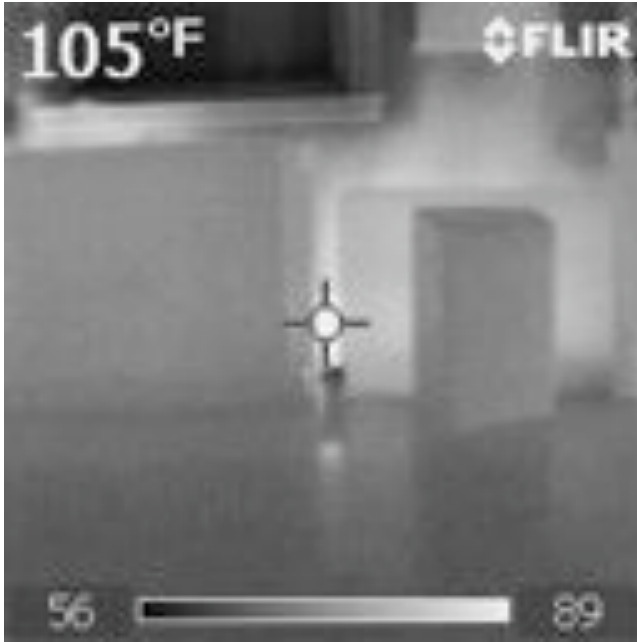
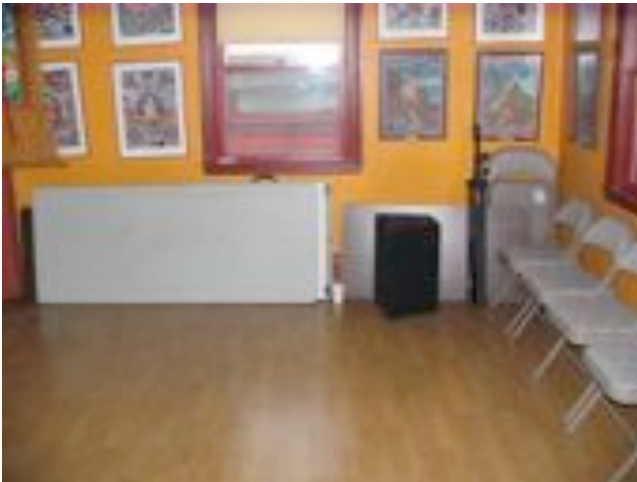
Items blocking baseboards and radiators accelerate heat loss to the outside of the building.

Rather than allowing free air convection to distribute the baseboard heat through the room, these items are blocking the air circulation from the baseboard, heating the wall behind excessively, and so accelerating heat loss through the outside walls. Unblock all radiators and baseboards for most effective heat distribution, room temperature uniformity, and to reduce unnecessary heat loss.

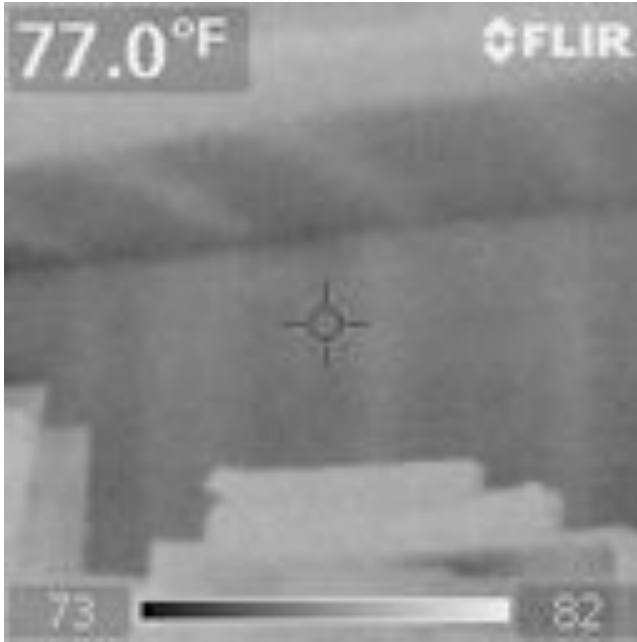
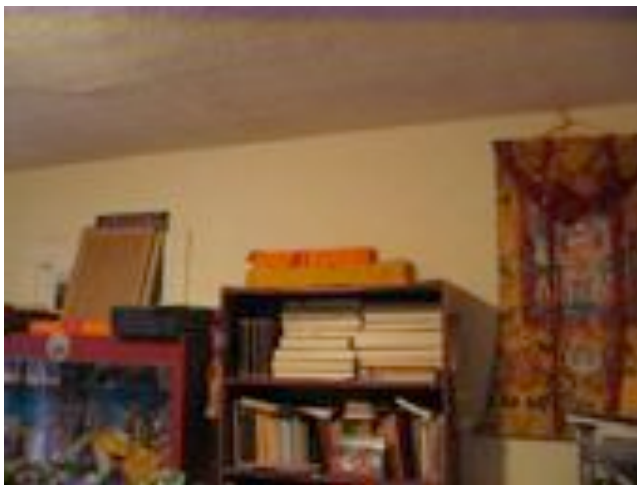
In some areas, both wall and ceiling insulation appears to be missing, or performing poorly.

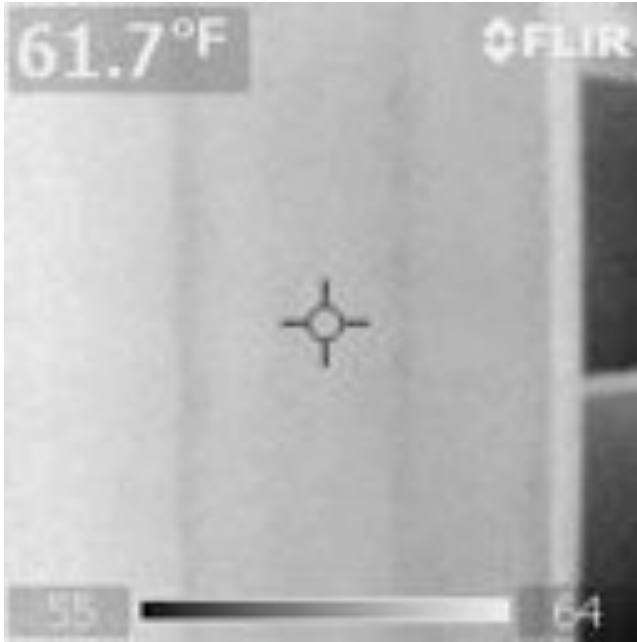
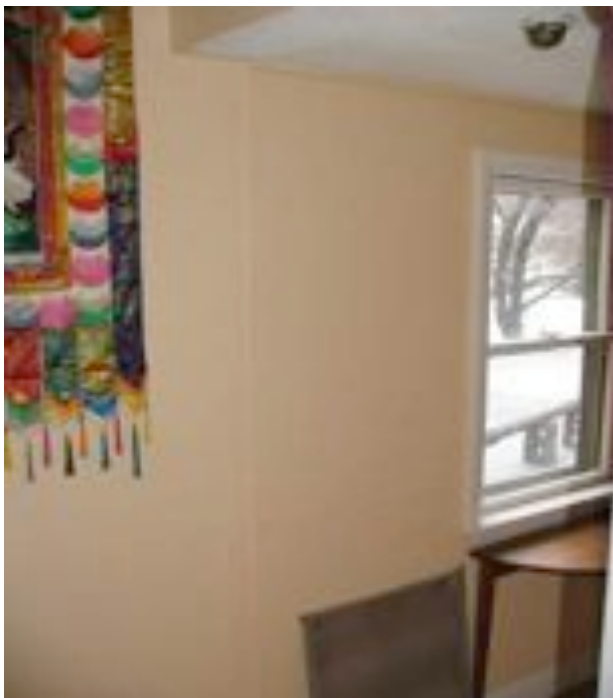
A few areas were found that appear to have some wall insulation, how effective it may be is unknown.

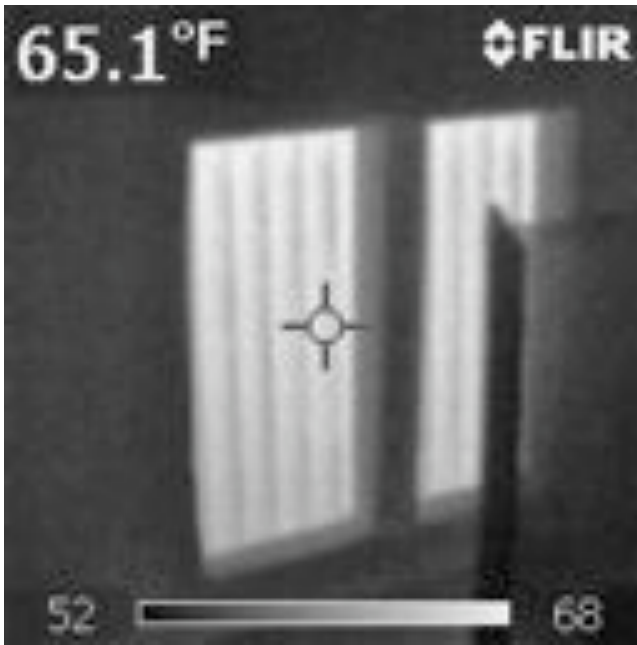
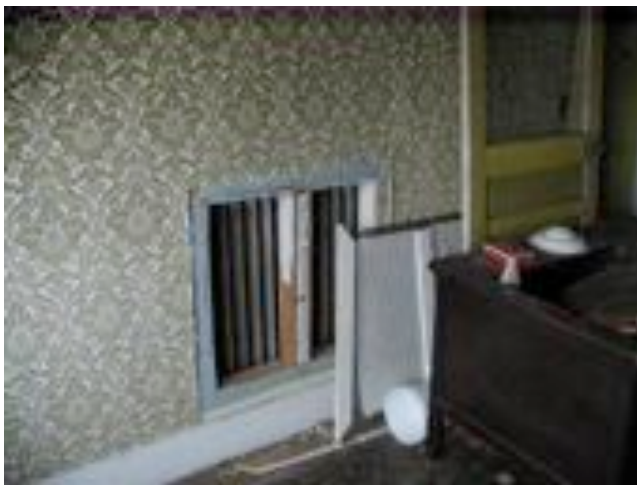
Apparently the heating system is distributing some low grade heat to the third floor.

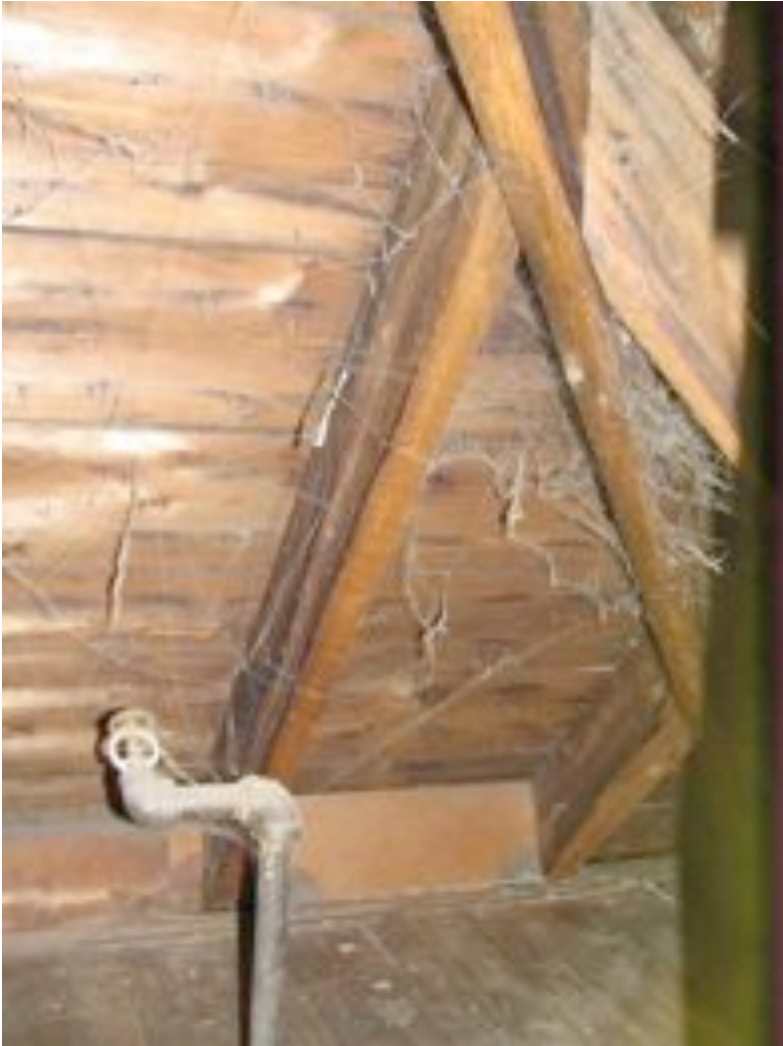
There is a (possibly water filled) fire suppression system in the third floor eaves.

There is potential for significant water damage should these pipes freeze and burst, or should the sprinkler heads freeze and burst. Should the pipes freeze, the proper operation of the fire suppression system could be impeded.

This sprinkler head is located outside the thermal boundary, in a drafty location behind a knee-wall (Note cobwebs indicating frequent air movement) with very significant potential for freezing.

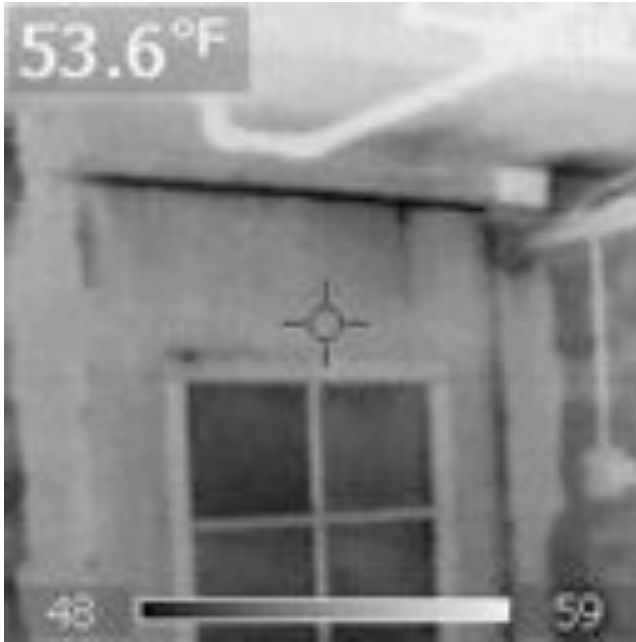
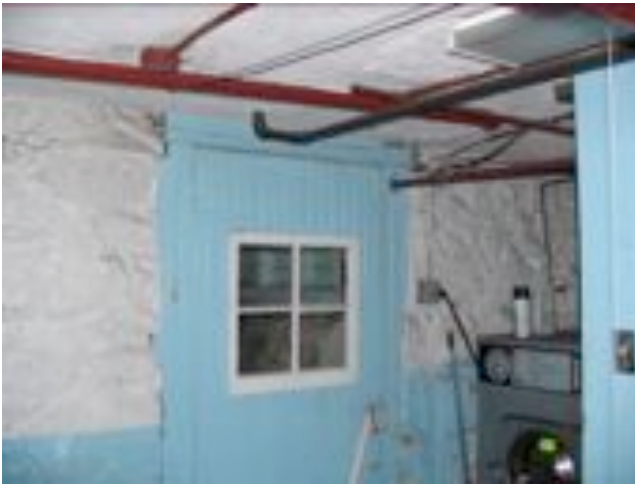
Air leakage around basement door admits a fair amount of cool air into the basement (a high stack pressure area) due to outdoor to indoor temperature driven stack effect.

This air is warmed by the heating system and rises up through the building, escaping at the top of the building carrying with it a great deal of heat, and moisture, dehumidifying the building in the winter.

The other basement door in the rear of the building has even greater air infiltration, exterior light is visible around the wooden casement of the door.

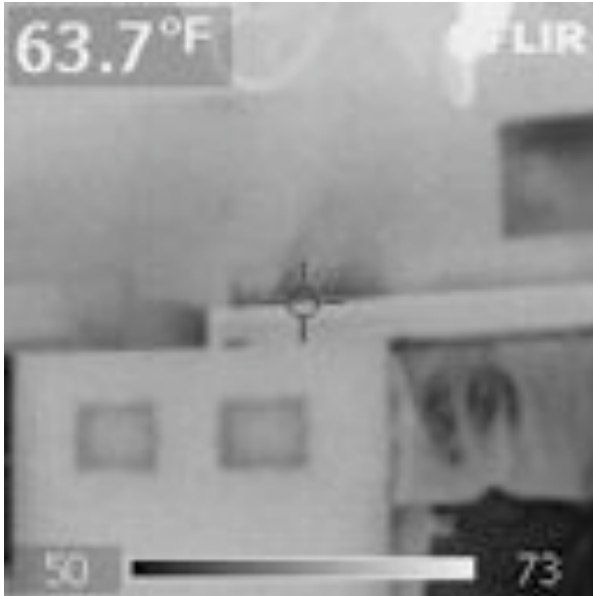
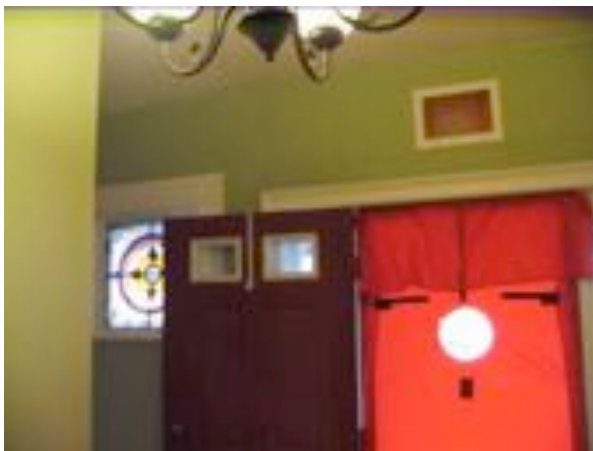
The blower door was installed in the front door. Air leakage (thin, wispy streams of dark cool air) are visible from behind the door above the left side lite trim. This is not a major cause of the high air infiltration, but is very easy to remedy with a bit of caulk.

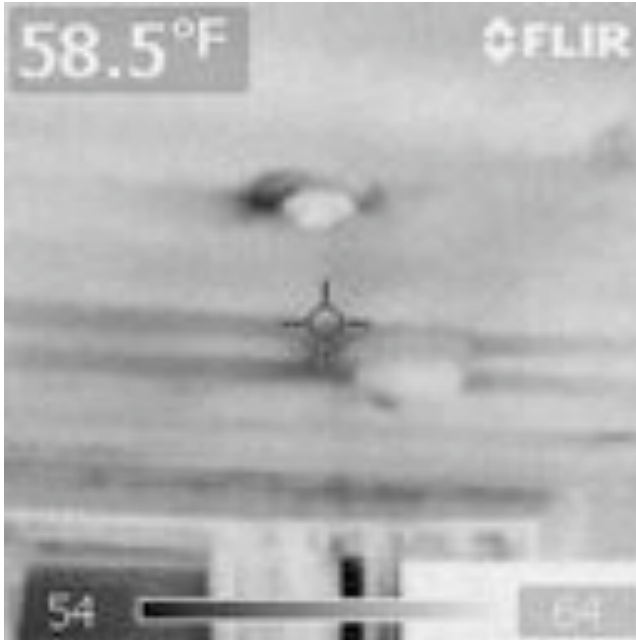
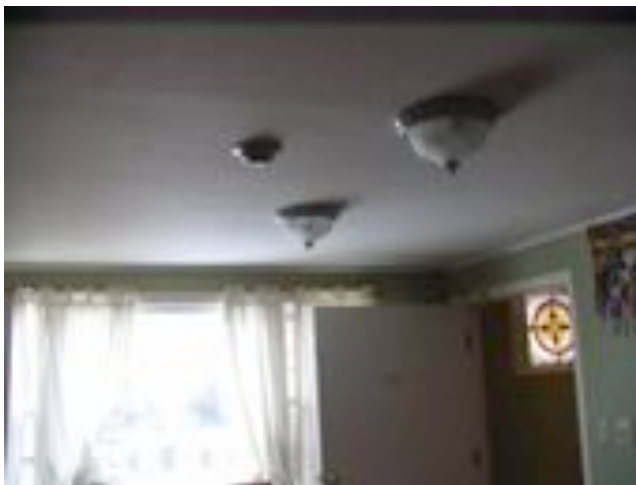
The ceiling lights exhibit the thin, wispy, patterns characteristic of air infiltration.

Although not a major loss of energy, this illustrates what is likely poor air sealing in the single story ceiling in this area. This could cause wind washing of fibrous ceiling insulation, reducing the efficacy.

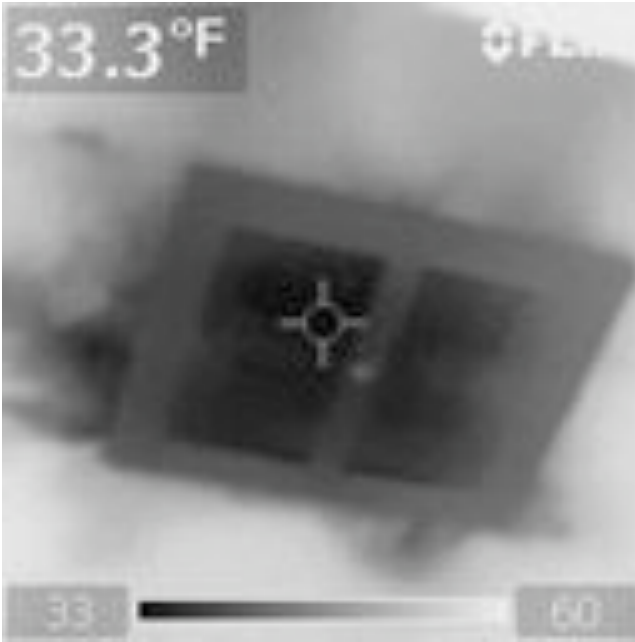
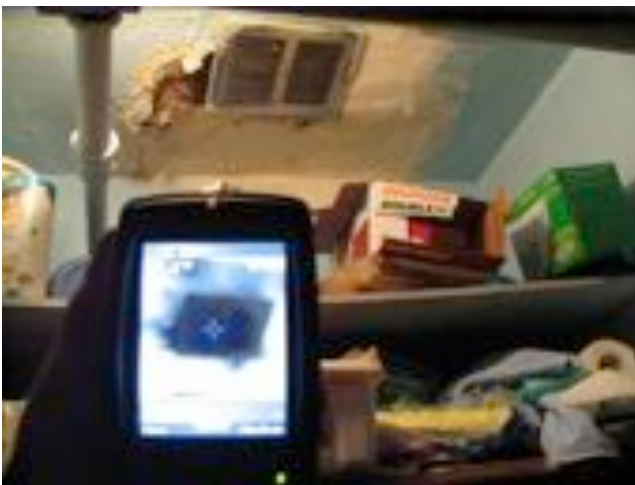
There appears to be no damper in this vent, and so very low (approximate) temperature air enters.

It may be that the damper in this fan is stuck open. This fan appears to be similar to that fan on the left bathroom at the entrance to the large room in the newer, left side of the building. In that left bathroom, if you operate the fan and then turn it off and wait 5 to 10 seconds, you can hear the damper close, and this is why that left bathroom vent has much less air infiltration.

When this area is repaired, proper damper operation should be ensured.

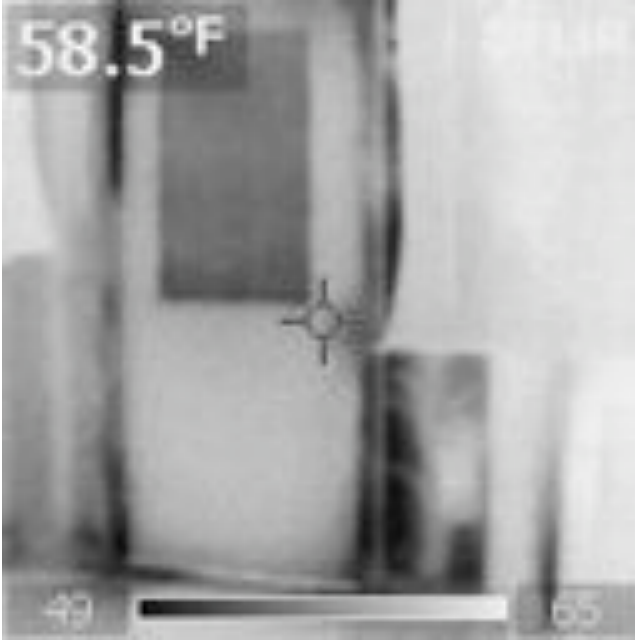
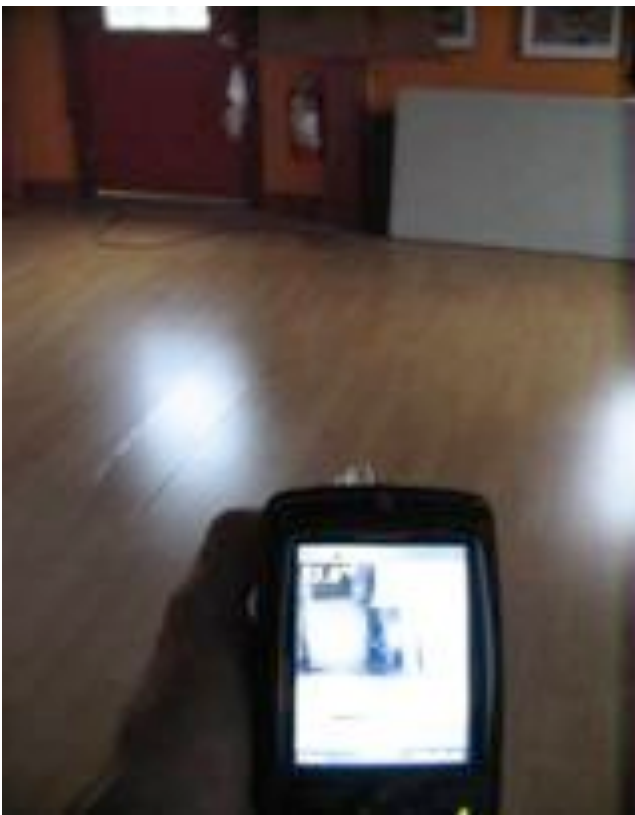
Whispy patterns characteristic of air infiltration are apparent at the periphery of the door trim. This is not a very large energy loss factor, but it can be a comfort factor and is easy to fix with caulk and / or paint. Also, as is the case with many of the exterior doors in this building, adjusting the striker place position slightly to compress the door gaskets can greatly reduce the air infiltration.

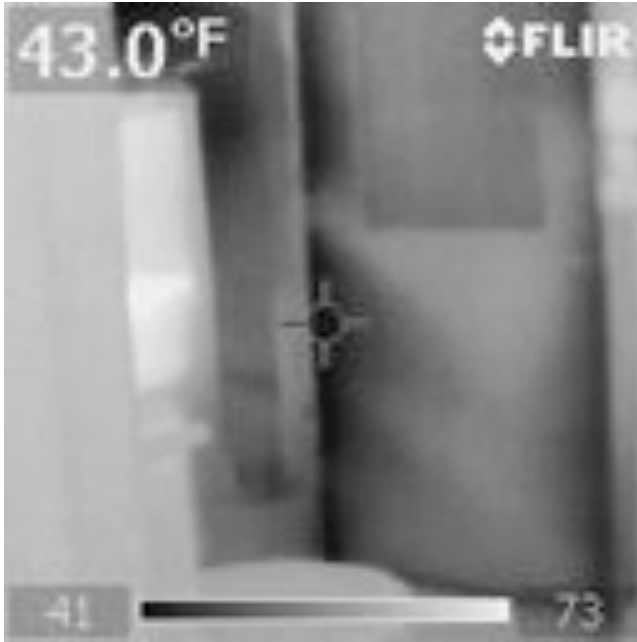
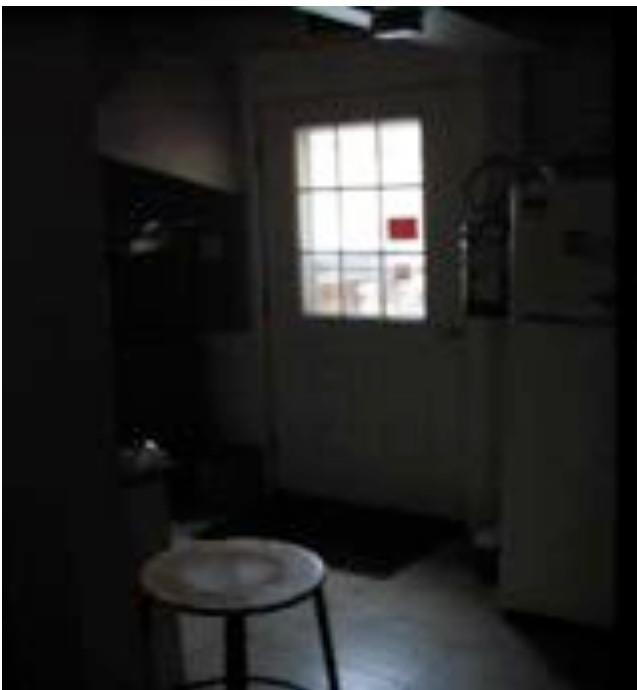
A large amount of air infiltration for an exterior door.

The door gasket is in good condition, the striker plate simply needs adjustment to compress the gasket. Not a very high energy loss area, but a comfort factor for those dining in this area, and easy to repair.

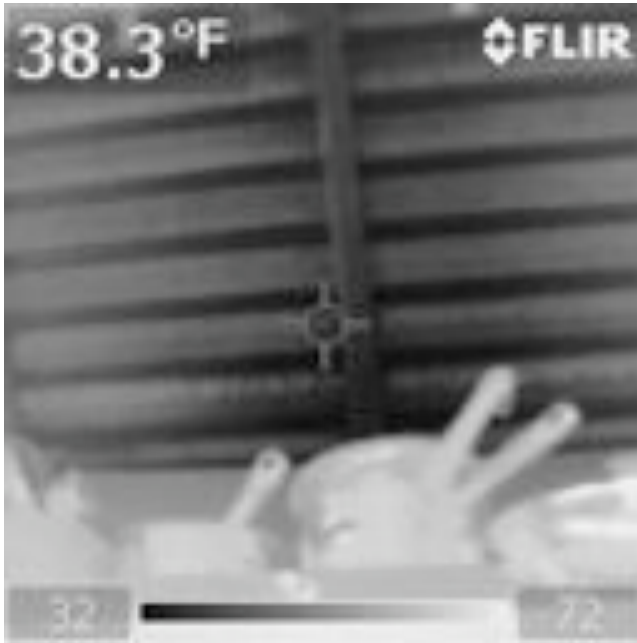
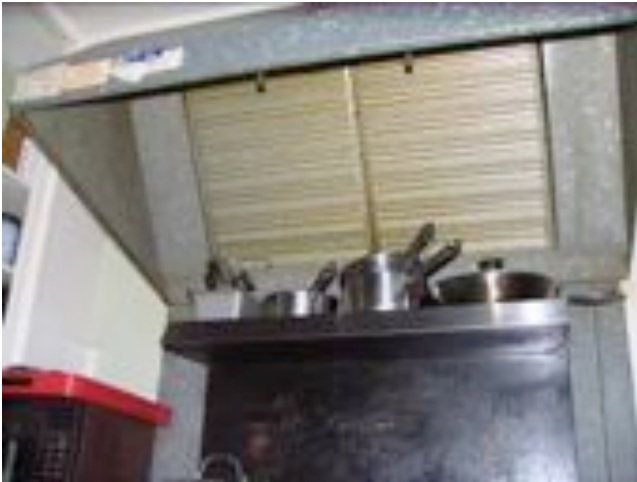
This is a very high air infiltration site.

Typically you may not feel cool air in this location, because warm air typically escapes up the vent. This is a likely a very high heat loss area.

If at all possible according to the local building and plumbing codes, etc., a damper should be installed or repaired to minimize loss of warm air out this vent when it is not in use.

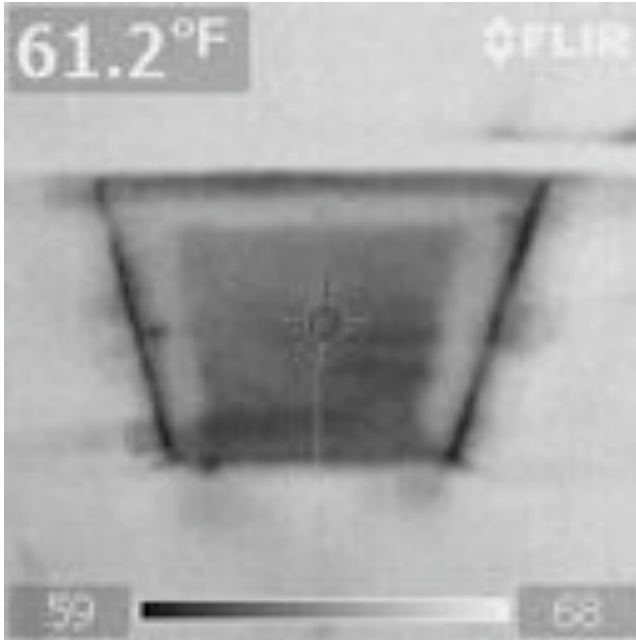
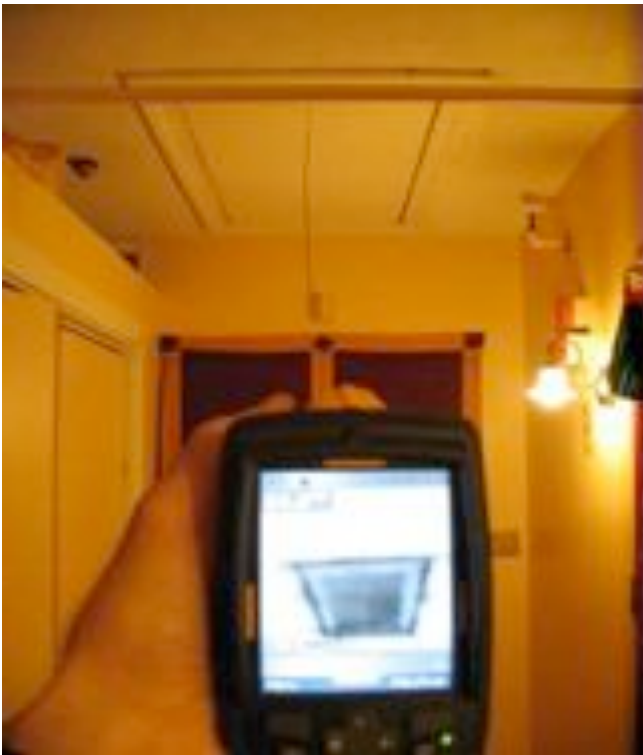
The third floor pull-down stairs demonstrate both air infiltration due to poor air sealing as well as no insulation of the attic stairs. A pliable high quality gasket, and an effective insulating cover are inexpensive and high return on investment improvements in this high stack effect area, if the ceiling of the second floor is to be the uppermost thermal boundary.

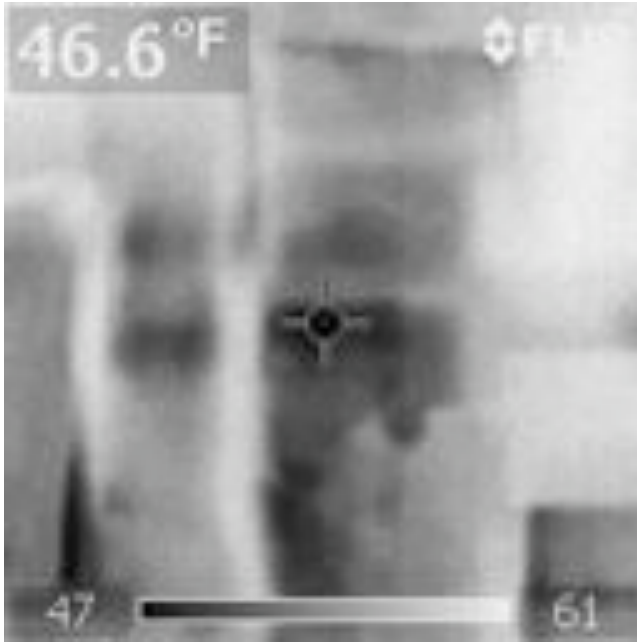
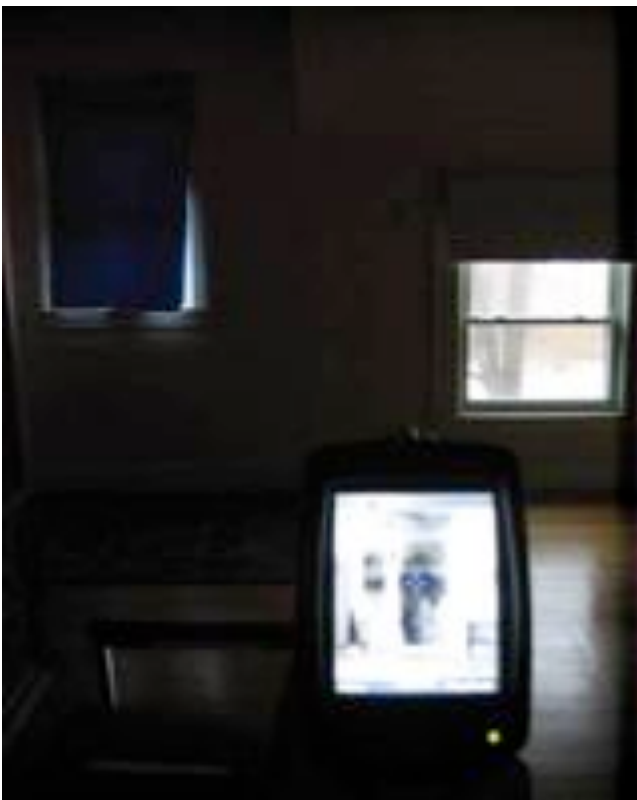
The blower door greatly amplified the heat loss in this area, air infiltration likely the reason, note the low approximate temperature of the interior wall surface. Wall surfaces this cool will make you 'feel' colder due to radiant heat loss, in addition to cooling the air in this room.

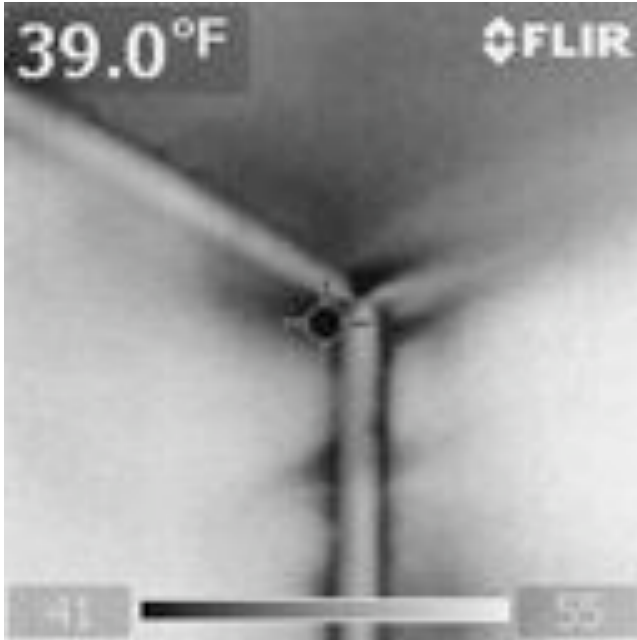
The right rear corner of the second floor closet over the newer portion of the building exhibited a fair bit of air infiltration that will tend to cool this closet excessively.

Although not a high energy cost item, it is relatively simple to remedy with caulk, paint, or some other air blocker.

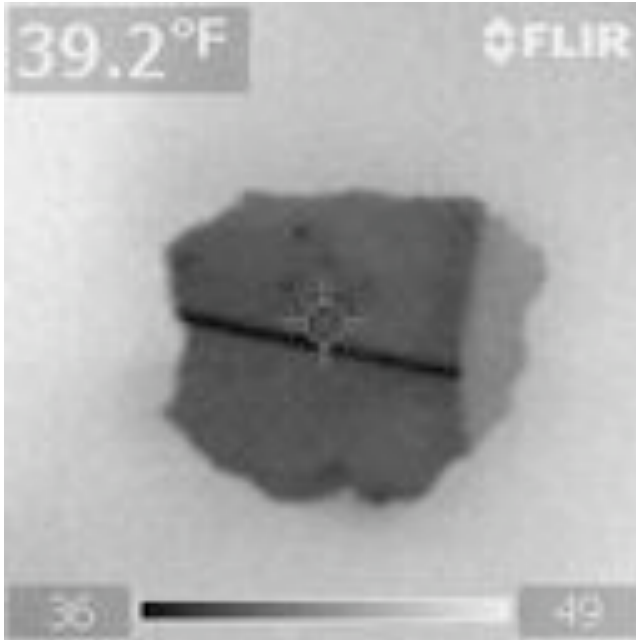
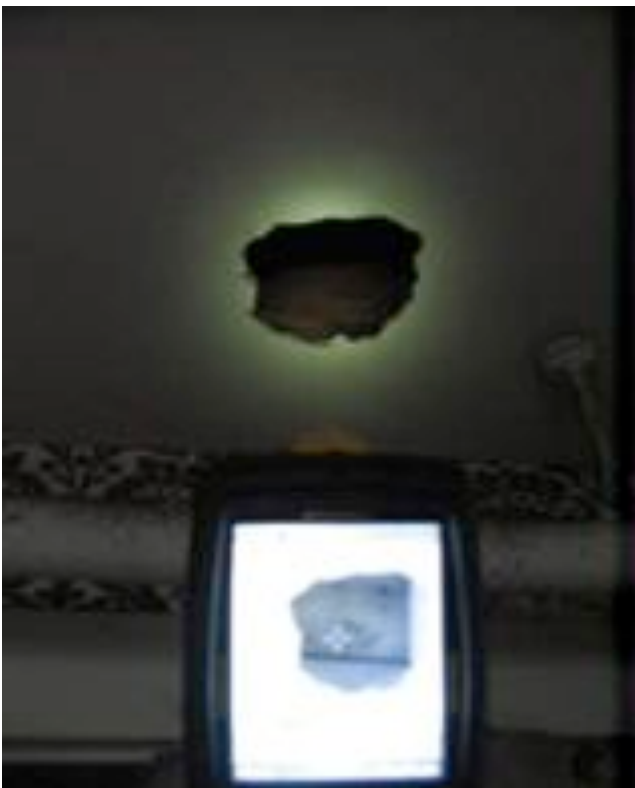
The floor of the third floor is not a very effective air barrier, and so holes in the third floor ceiling will make air infiltration worse. In this image the back of the roof sheathing is visible. If the intent is to keep the fire suppression system warm enough to keep the water inside liquid so that the system will function in the event of a fire on a cold night, the pipes must be kept above freezing. Remediation work should consider the impact of all building, plumbing and fire codes, as well as the possible consequences.

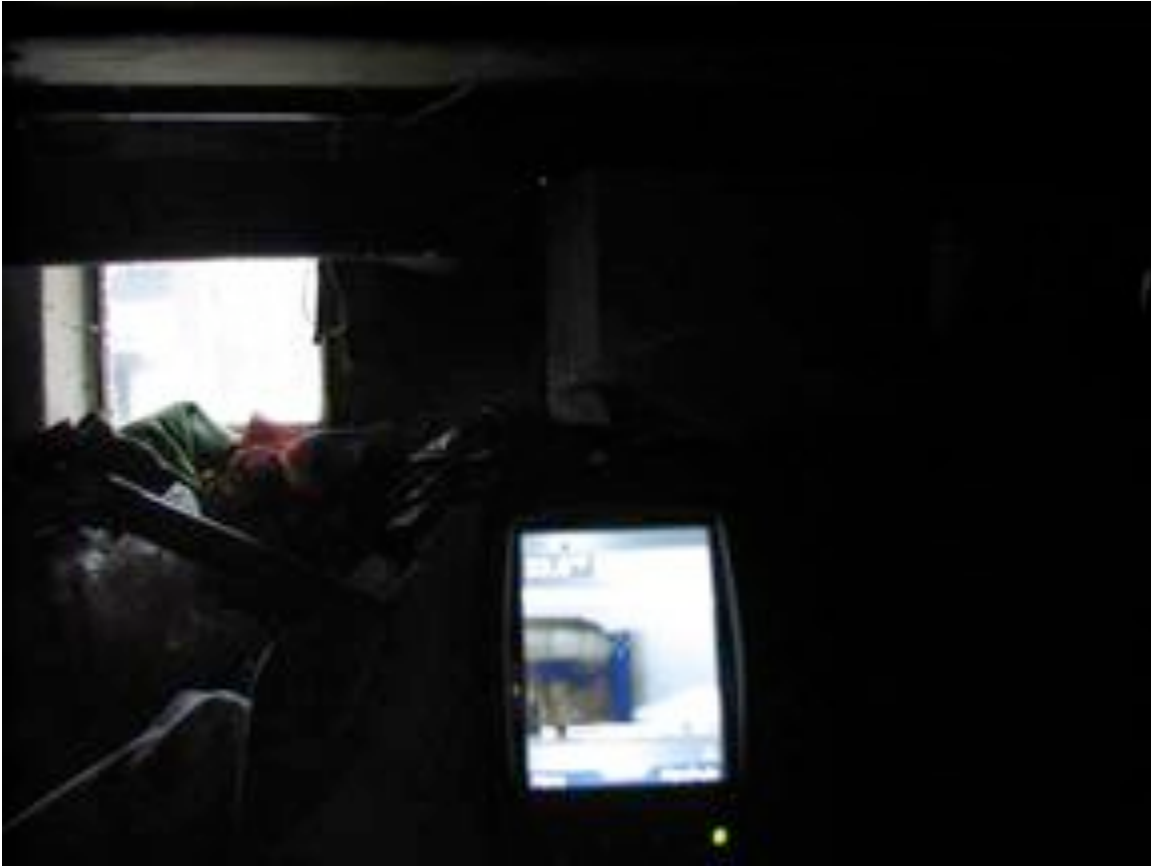
The approximate temperature of the air entering this basement window is in the low 30's.

Although this in itself is not a high energy cost item, it is one of many small things that could be improved which would contribute to savings over time.

This high stack effect area would benefit from inexpensive caulk.

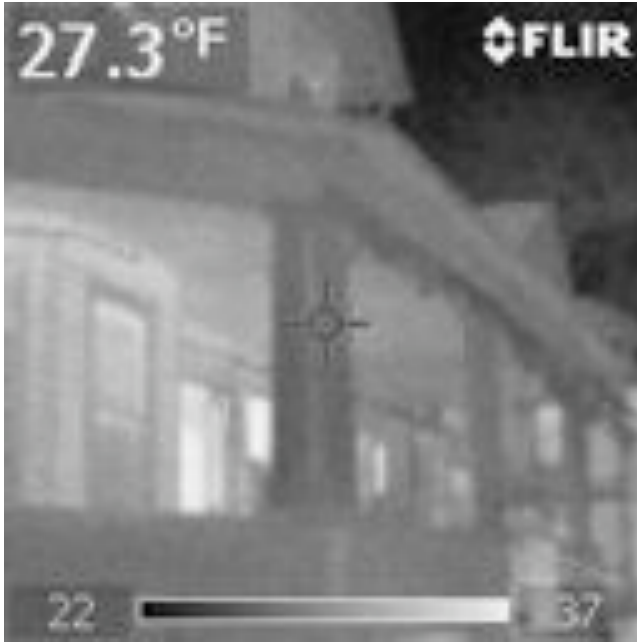
Wrap around porches in buildings of this vintage are notorious as a path for air infiltration.

It was noted that the underside of the porch ‘tongue and groove’ ceiling had been painted which would effectively block air infiltration from that path.

Still, a significant amount of air could be entering under the porch shingles, etc.

So this experiment was inconclusive.

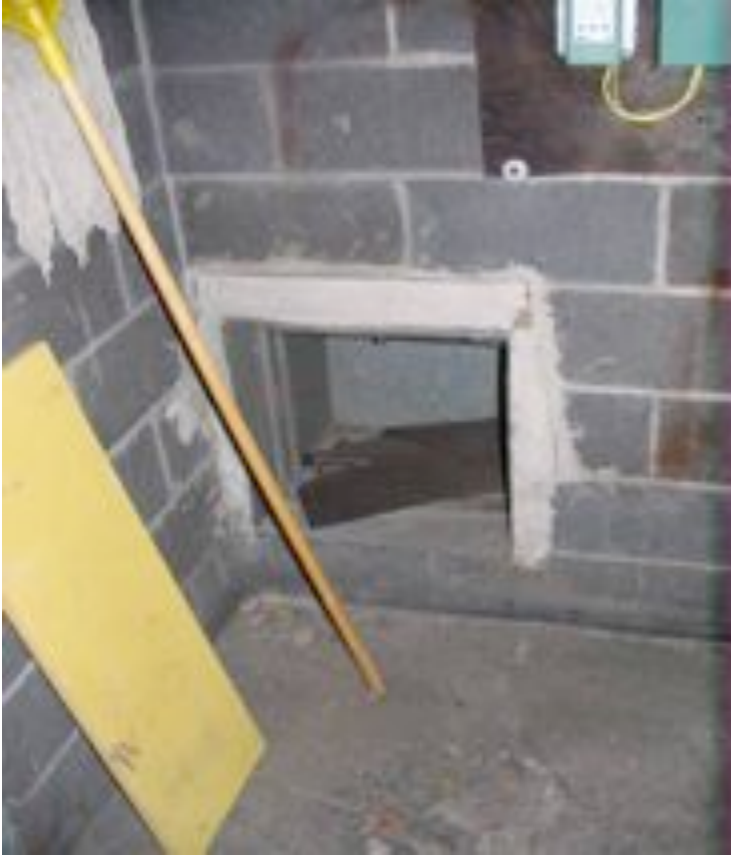
During blower door operation, the mechanical room in which the oil boiler is located was examined.

There is a very large amount of air entering this room from this very large external vent.

Interestingly, closing the mechanical room door had very little impact on the air infiltration as measured by the blower door, suggesting that this is could be a very significant source of air infiltration, and therefore heating cost.

The need for such a large vent should be investigated in terms of the local plumbing, building and fire safety codes, as well as the boiler manufacturer. It may be possible to introduce a controlled amount of air directly into the boiler in a way which has less impact on the total building air infiltration. See **Suggested Improvements** below.

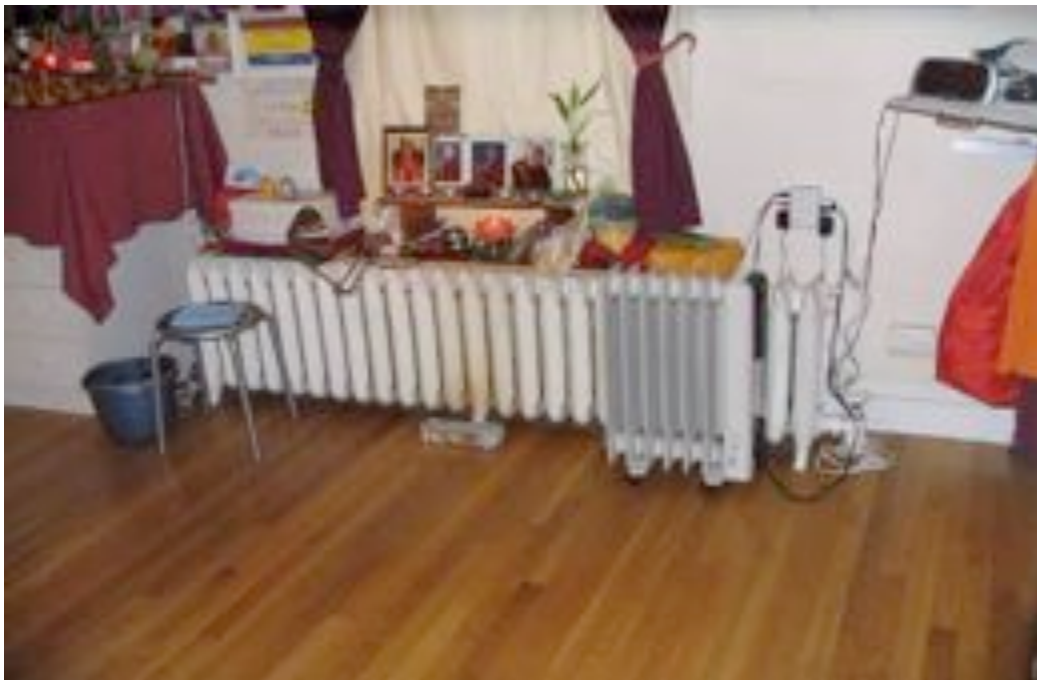
The items on top of the space heating radiator are blocking some of the convection airflow necessary to maximize the heat transfer from the radiator. Removing these items will result in more heat transfer to the room.

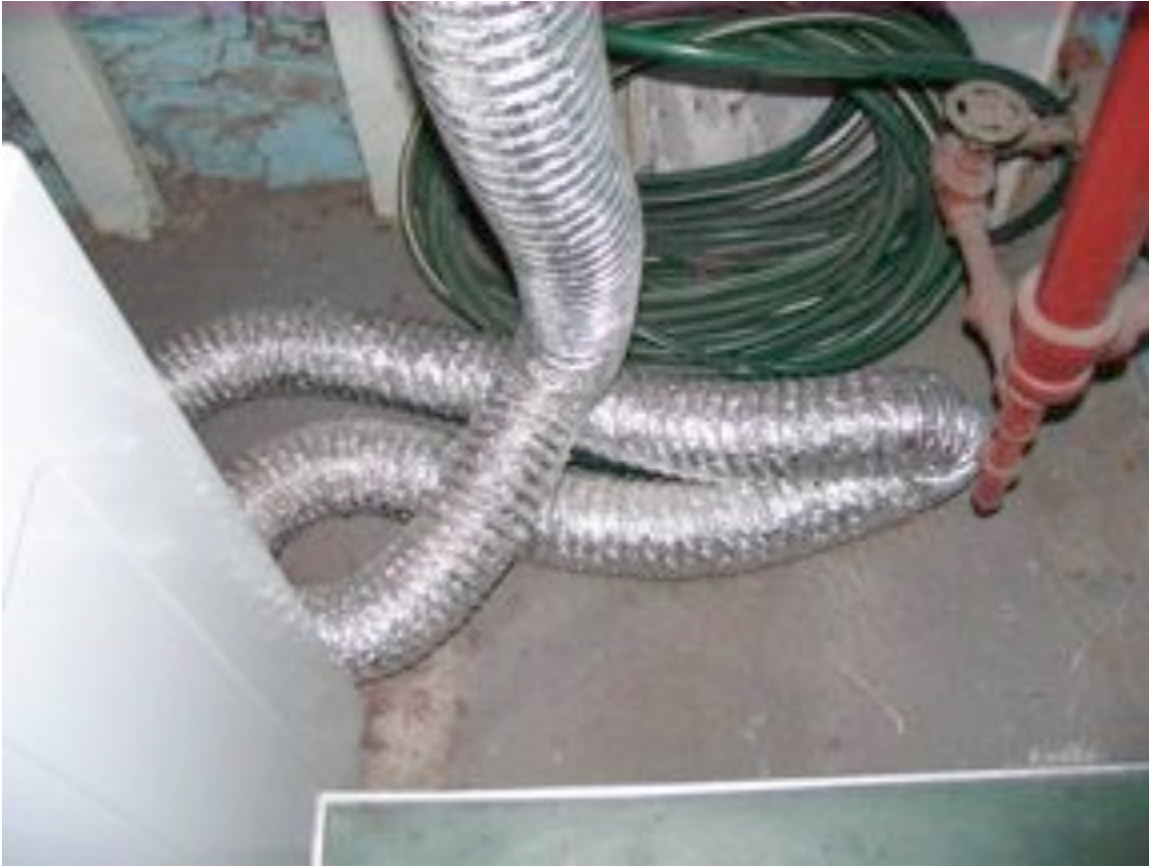
Care should be taken to route dryer outlet rigid metal pipe (preferred over flexible hose, and required by code in some areas for fire safety reasons) so that it has no sharp bends, and as few bends as possible, and is as short as possible. Long runs of dryer output air conduit can contribute to the premature failure of the dryer heating element due to excess temperatures. This will use excess electrical energy. The existing situation should be corrected.

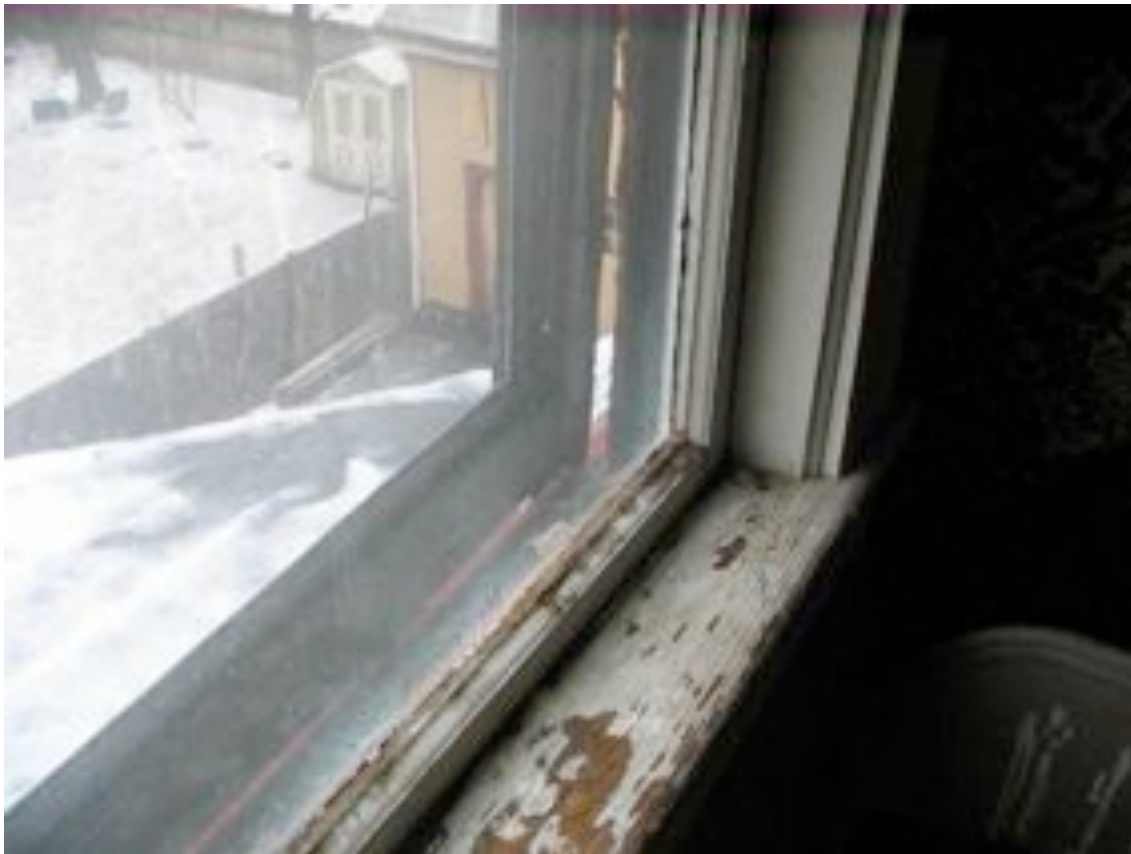
Some windows were observed with significant separation from the building, see the image below:
