# **Energy Audit Report**

## **68 Magoun Avenue, Medford, MA**

**Date:** December 23, 2008

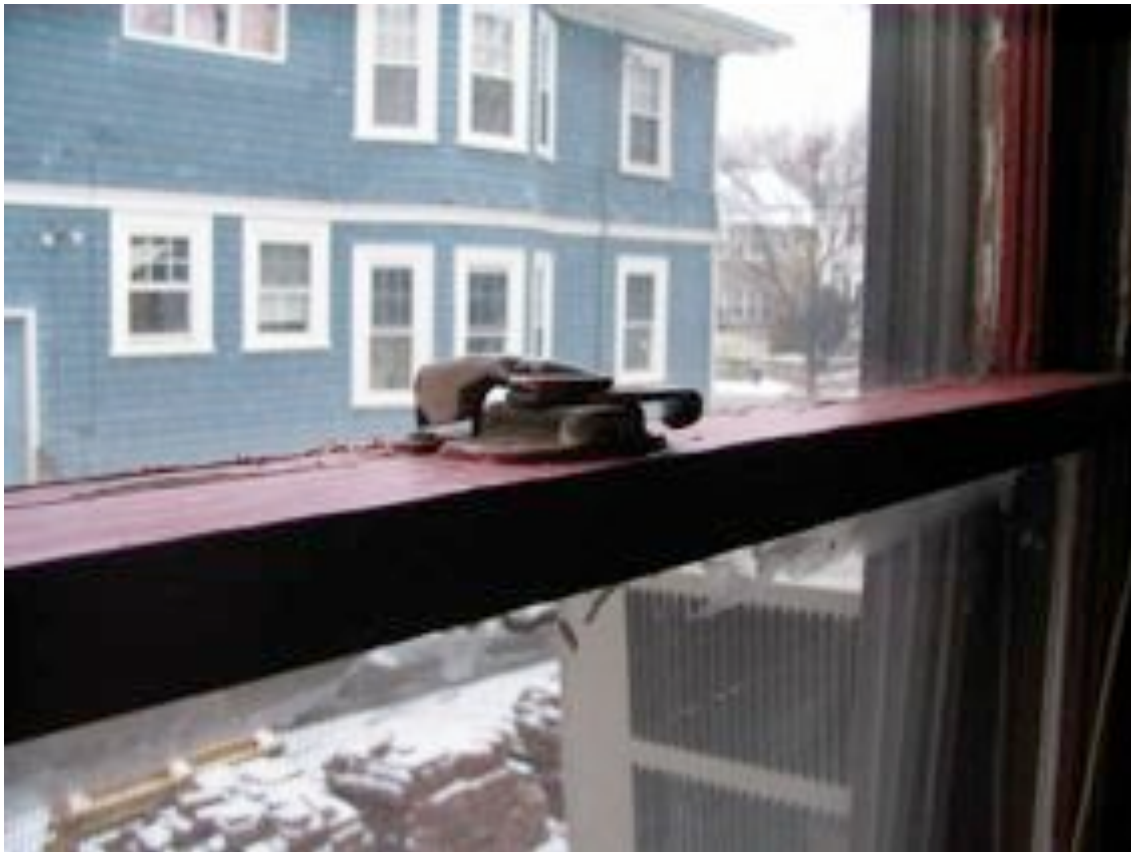
Windows were observed without sash locks, sash locks installed backwards (meaning they could never be used, and sash locks which were not closed, see image below:

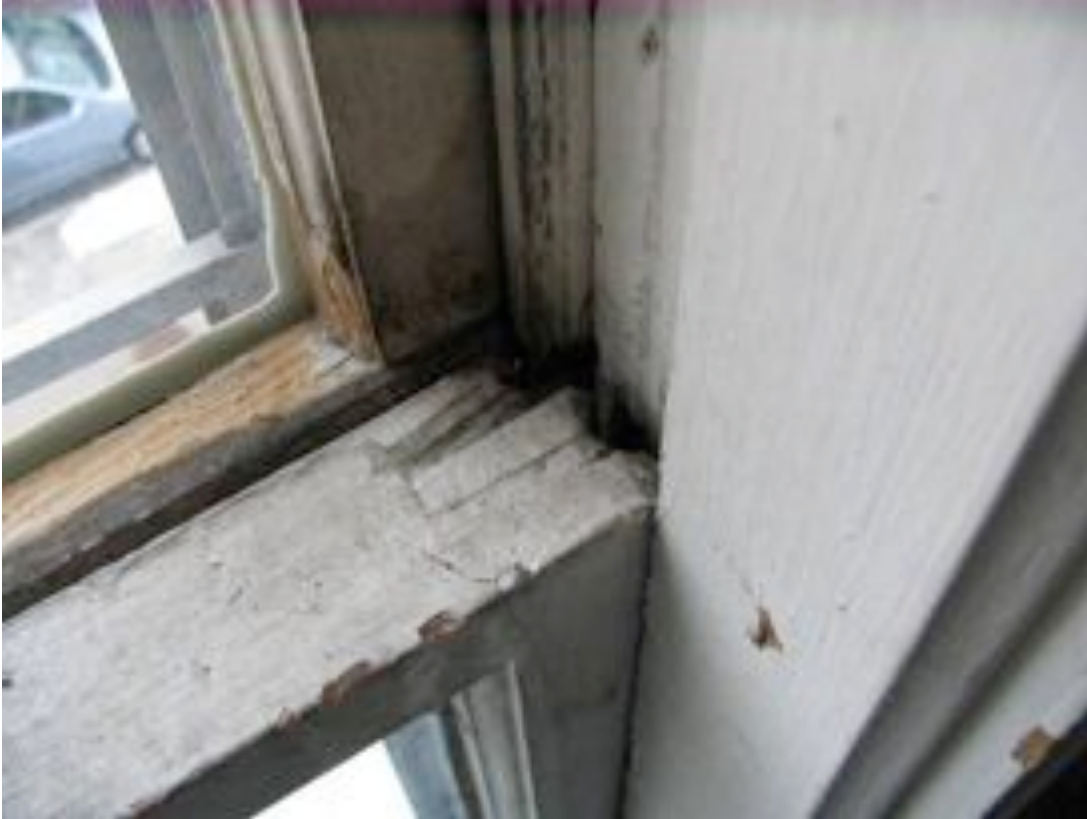
This sash lock was installed backwards, it cannot be used.
