# **Energy Audit Report**

## **68 Magoun Avenue, Medford, MA**

**Date:** December 23, 2008

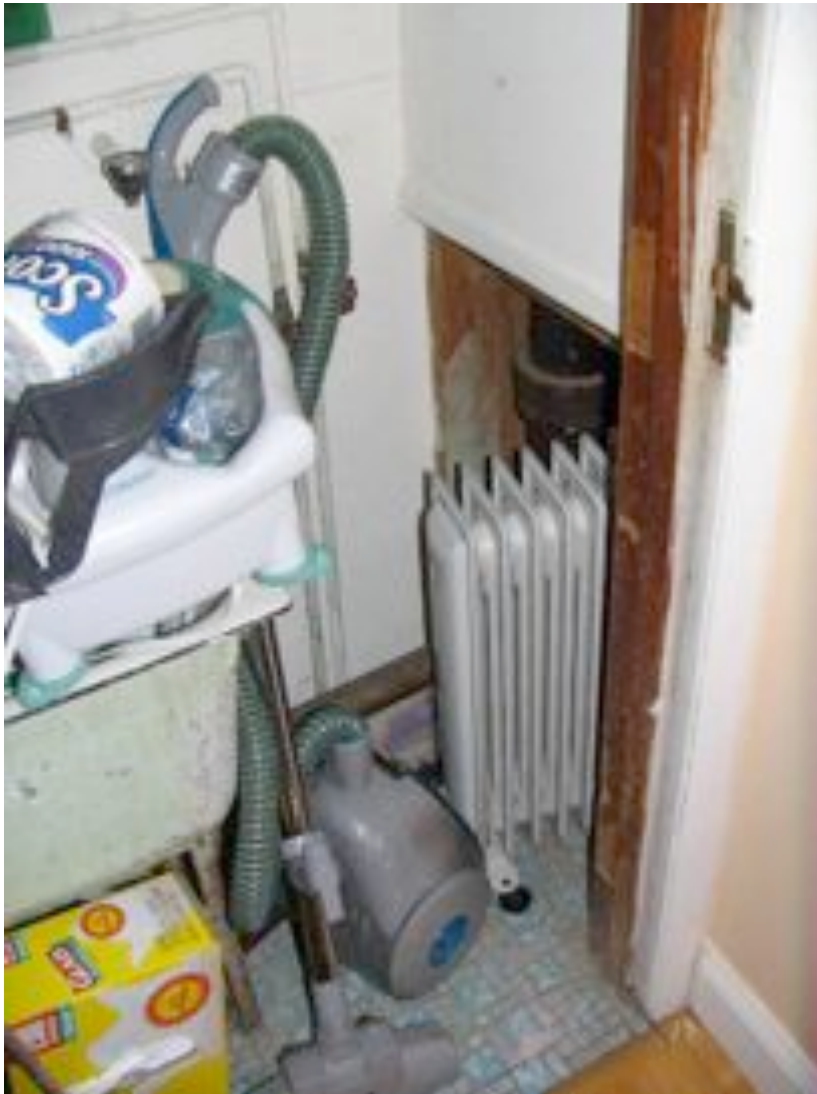
Fixing problems with the building can cost money, but this is a ‘one time’ cost that can avoid the recurring cost of paying for energy every year. It appears that an electric resistance heater might possibly be used to prevent pipes from freezing, refer to the following image:
